# Weekly Construction Report

## Hatchery Creek Design/Build Project

<b>Time Period (three weeks):</b>	November 16 – December 5, 2015	<b>Project No:</b>	1305
<b>Rain Days/Weather Conditions:</b>	<p>Rained ~1.5" on Wednesday, Nov. 18<sup>th</sup> starting at noon (Burkesville gauge) which limited work to only on spreading soil on the Disposal Area and wrecking concrete forms on Thursday.</p> <p>Did not work Nov. 26<sup>th</sup> &amp; 27<sup>th</sup> due to Thanksgiving holiday.</p> <p>Rained ~3.1" from Nov. 28<sup>th</sup> - Dec. 1<sup>st</sup> and did not work again until Dec. 3<sup>rd</sup>.</p>		
<b>Personnel on-site:</b>	<p><i>EcoGro/Ridgewater:</i> Tom Cutter, Eric Dawalt, Jim Hanssen, Larry Mounce, Brad Redmon, Randall "Mokie" Starns, Randall Starns, Jr., Sherri Arthur Trucking-John Arthur.</p>		
<b>Equipment on-site:</b>	<p>Komatsu PC 360 excavator w/ hyd. thumb, Komatsu PC 160 w/ hyd. thumb, Terex TA27 articulated off-road dump truck, Bobcat T300 skid steer, &amp; Morooka 2200 track dump truck. The Komatsu PC 210 excavator and Komatsu PC 240 excavator were removed from production and rental on Nov. 19<sup>th</sup> but not de-mobilized until the next week. The sheepsfoot com

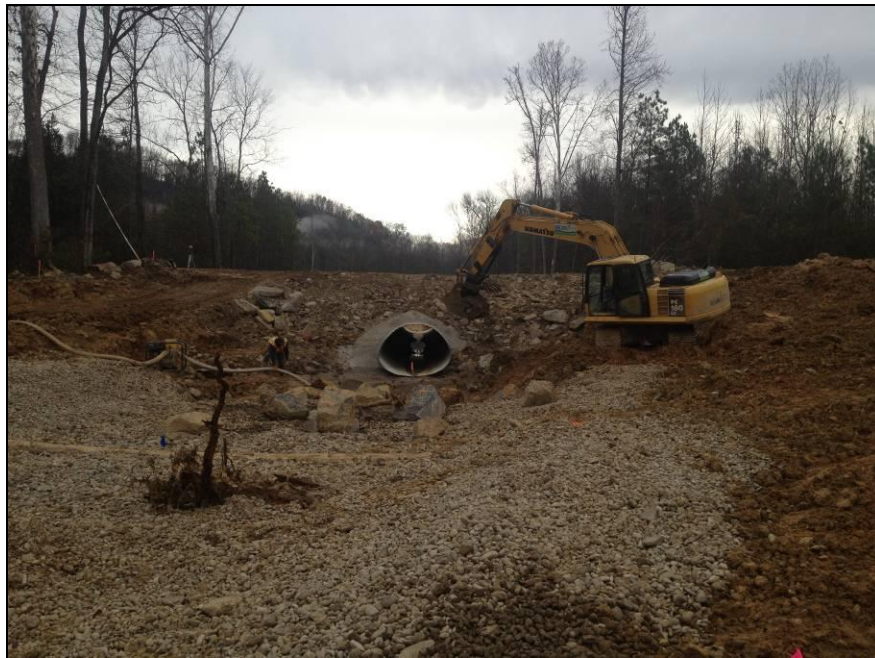
*Finishing construction of the stream next to the Campground Road culvert. (Picture taken looking downstream towards Campground Road).*

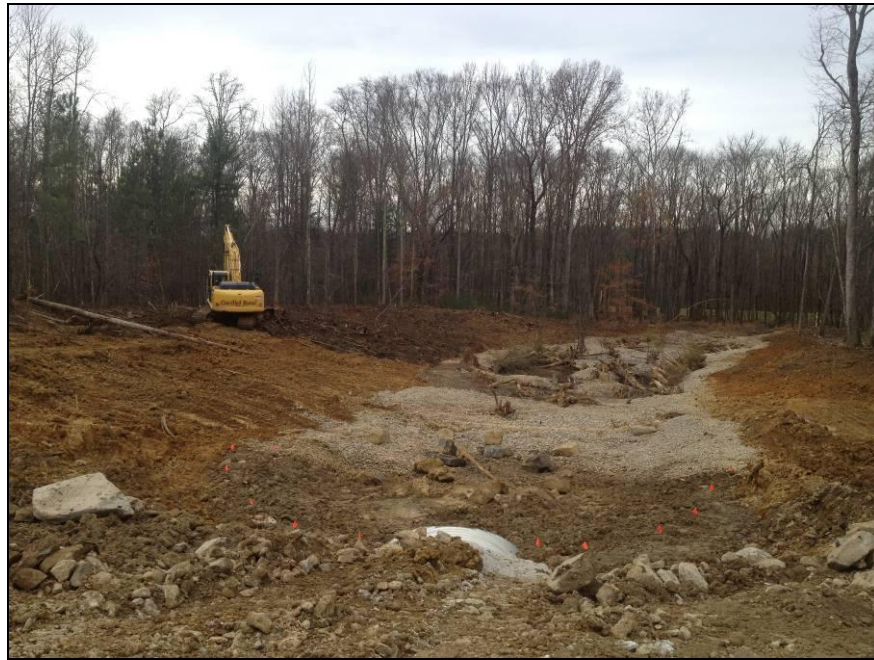
***Finish grading soil and spreading stockpiled wood on Right Descending Bank (RDB) of stream.  
(Picture taken looking upstream from Campground Road).***

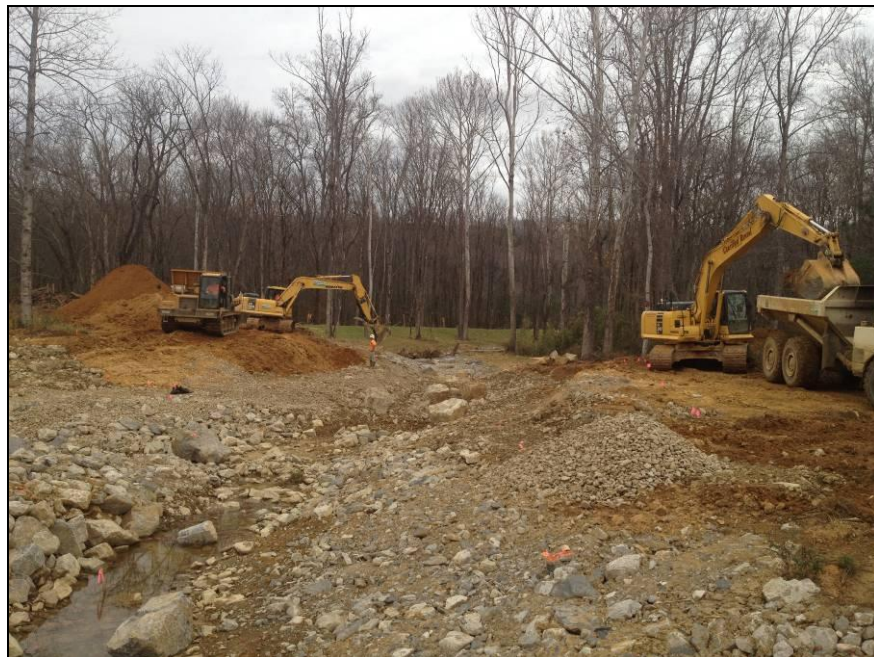
***Finishing construction of stream downstream of Migration Barrier. (Picture taken looking  
downstream from bridge).***

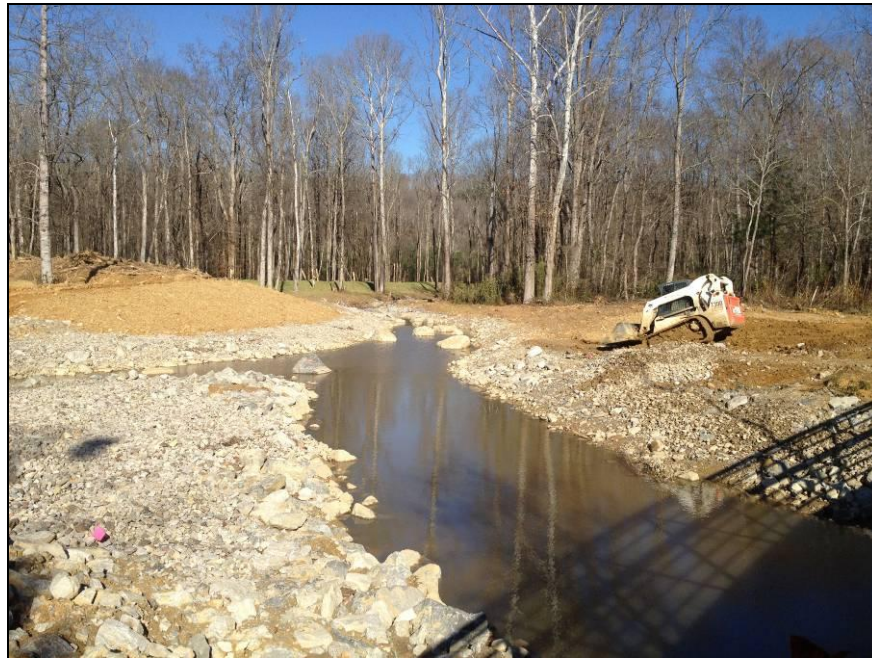
***Finish grading next to stream downstream of Migration Barrier. (Picture taken from approximately same location as above).***

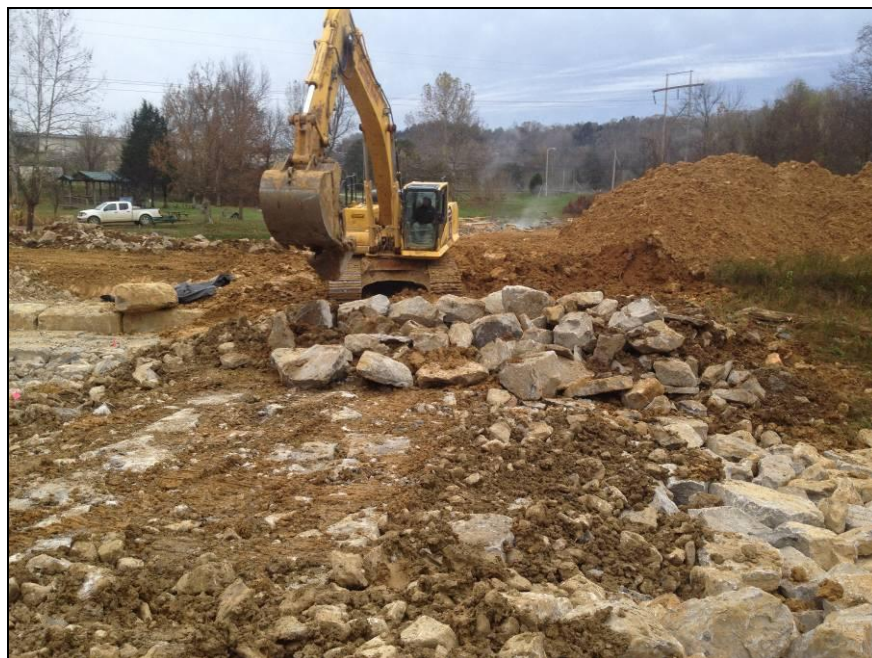
***Ravine Spillway: Installing rocks (D50 of 24") over geotextile from ~Sta. 0+30 to 0+50 on LDB of ravine spillway. (Picture taken looking at LDB of ravine spillway and upstream on LDB of stream channel).***

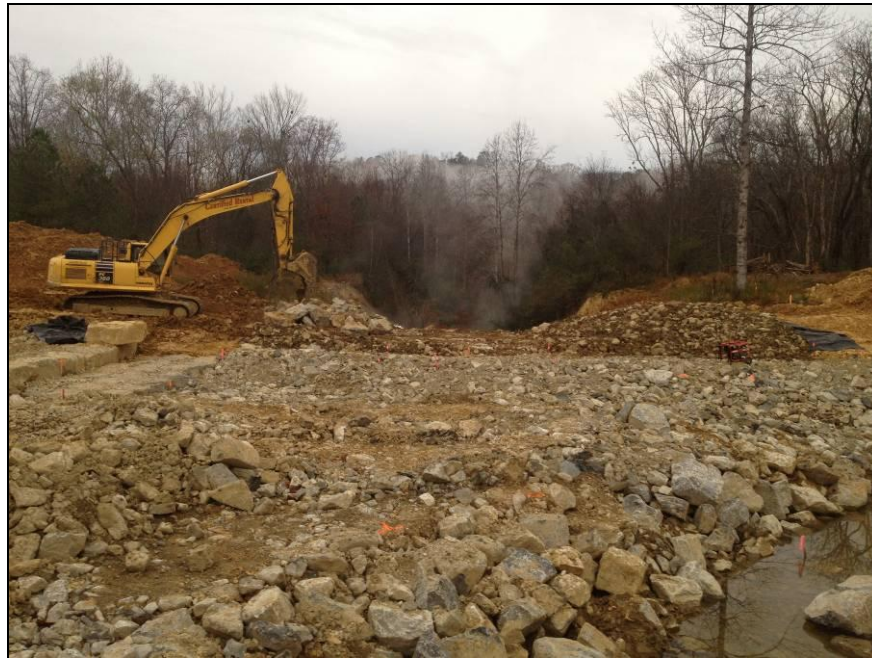
***Same location as above: Installing rocks (D50 of 24") over geotextile from ~Sta. 0+30 to 0+50 on LDB of ravine spillway. Large rocks on RDB of ravine spillway have been covered with shot rock to fill void spaces. (Picture taken looking downstream in ravine spillway from confluence bar).***

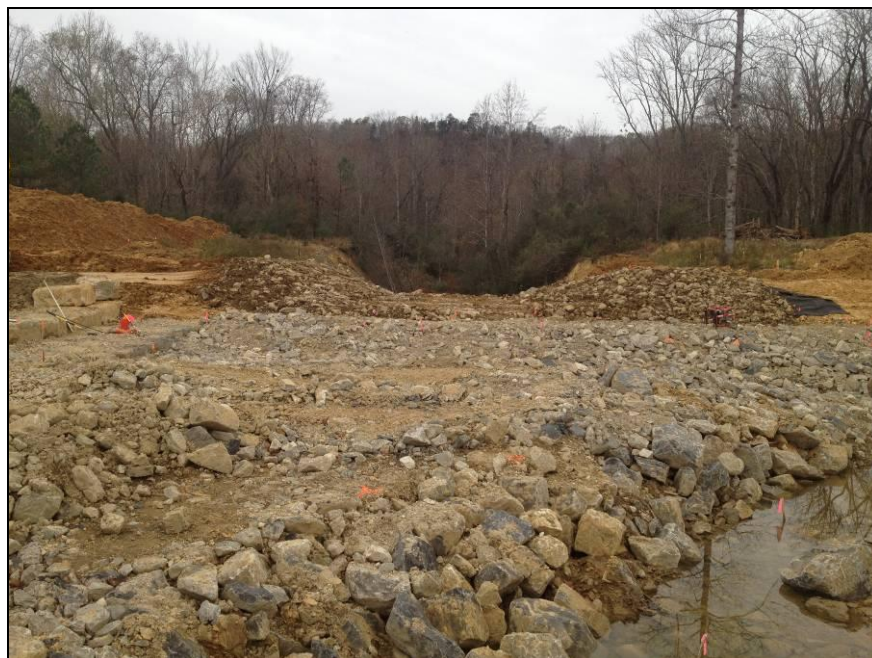
***Same location as above: Large rocks on both banks of ravine spillway have been covered with shot rock to fill void spaces. (Picture taken looking downstream in ravine spillway from confluence bar).***

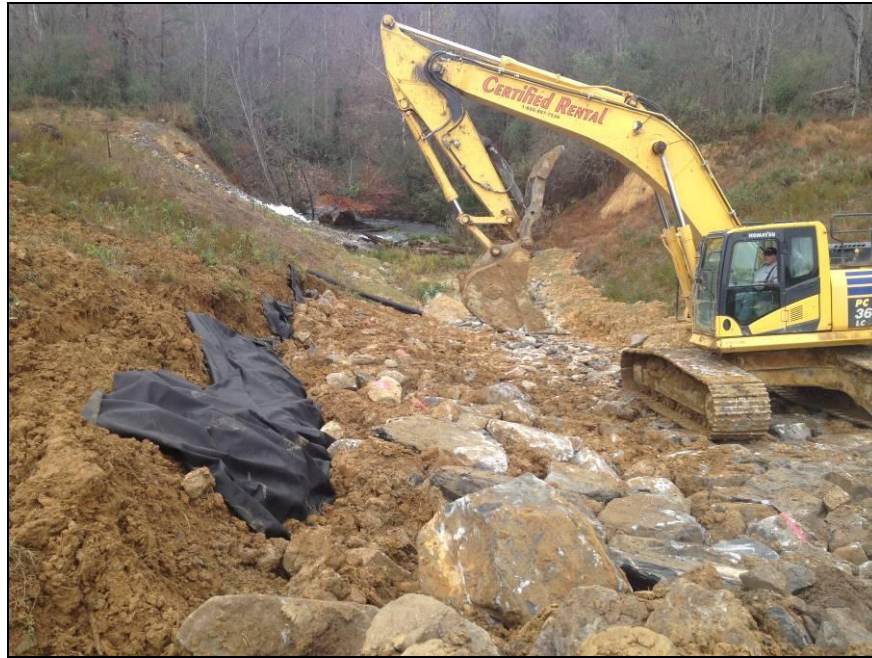
***Ravine Spillway: Installing rocks (D50 of 24") over geotextile. (Picture taken looking downstream in spillway on LDB at ~Sta. 0+50).***

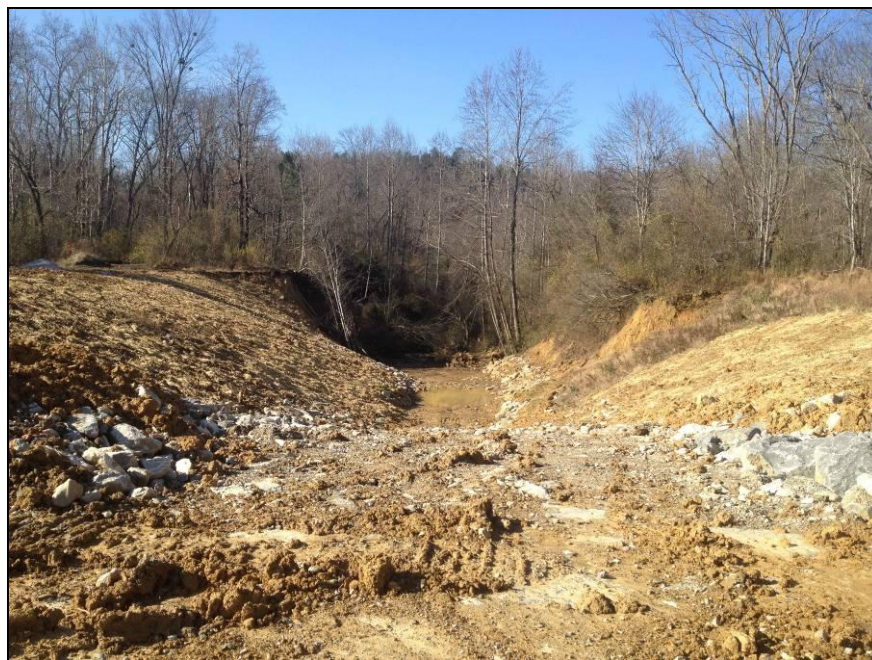
***Ravine Spillway: Large rocks in bottom of spillway have had shot rock installed in void spaces. Side slopes have been covered with soil. Constructed plunge pool and toe armor can be seen in background. (Picture taken looking downstream in spillway at ~Sta. 0+30).***

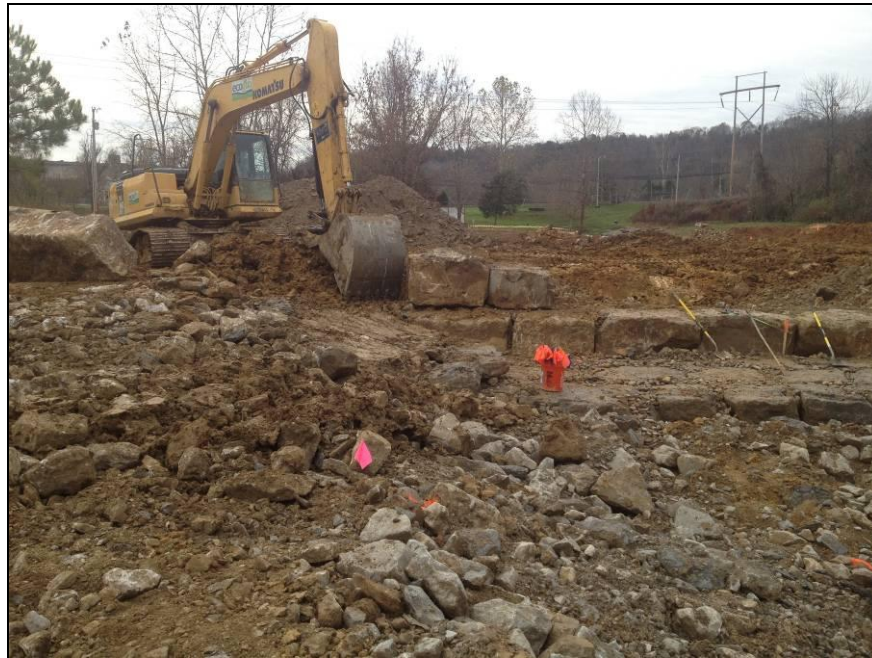
***Installing side rocks of Migration Barrier. (Picture taken looking upstream at RDB of Migration Barrier).***

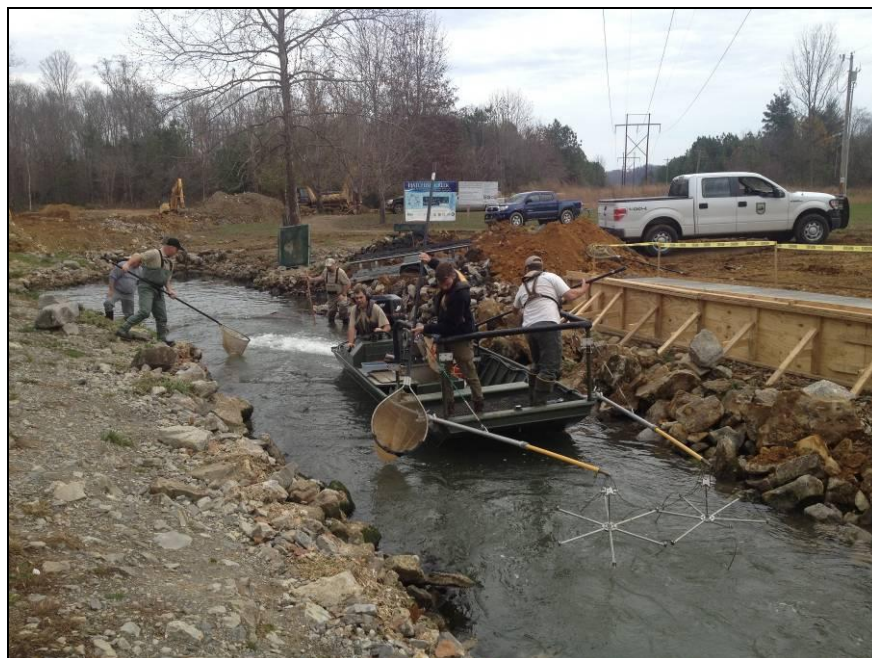
***KDFWR personnel shocking fish and removing them from PFA. (Picture taken looking downstream next to new handicap sidewalk).***

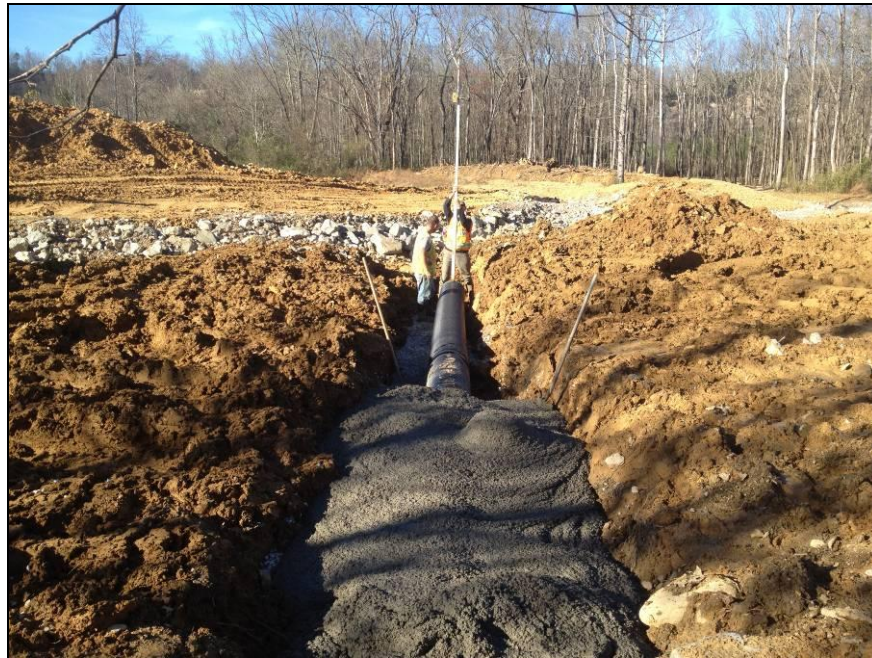
***Public Fishing Area: Installing new 15" HDPE pipe to extend existing pipe to stream. (Picture taken looking towards stream from existing gravel trail on RDB @ ~Sta. 105+00).***

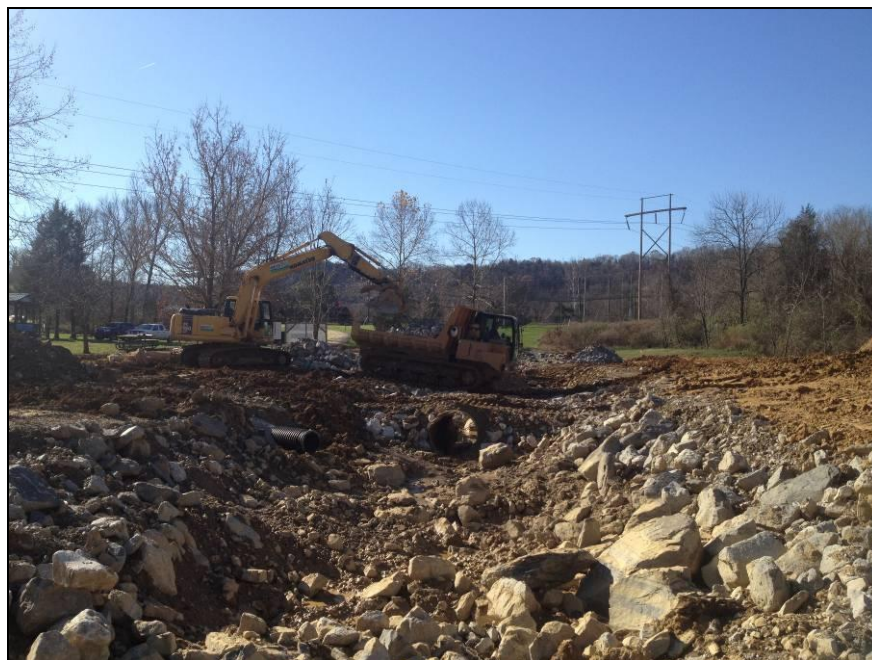
***Public Fishing Area: Loading shot rock to haul across temporary culvert in stream to build stream channel banks. (Picture taken Migration Barrier looking upstream).***

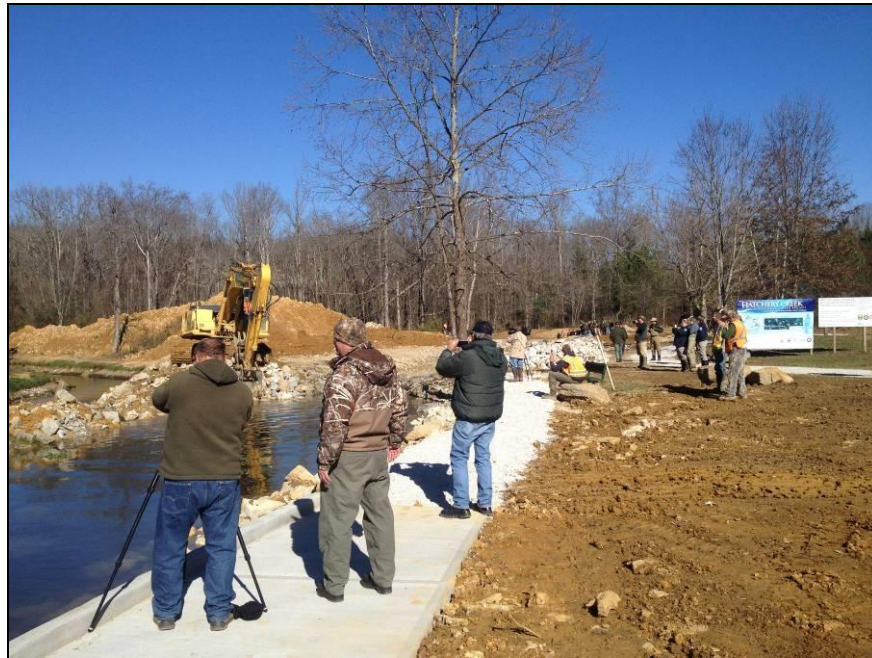
***Public Fishing Area: Diverting water from temporary diversion channel permanently into the new stream. It was a momentous occasion captured by not just a few cameras. (Picture taken looking downstream from new sidewalk).***

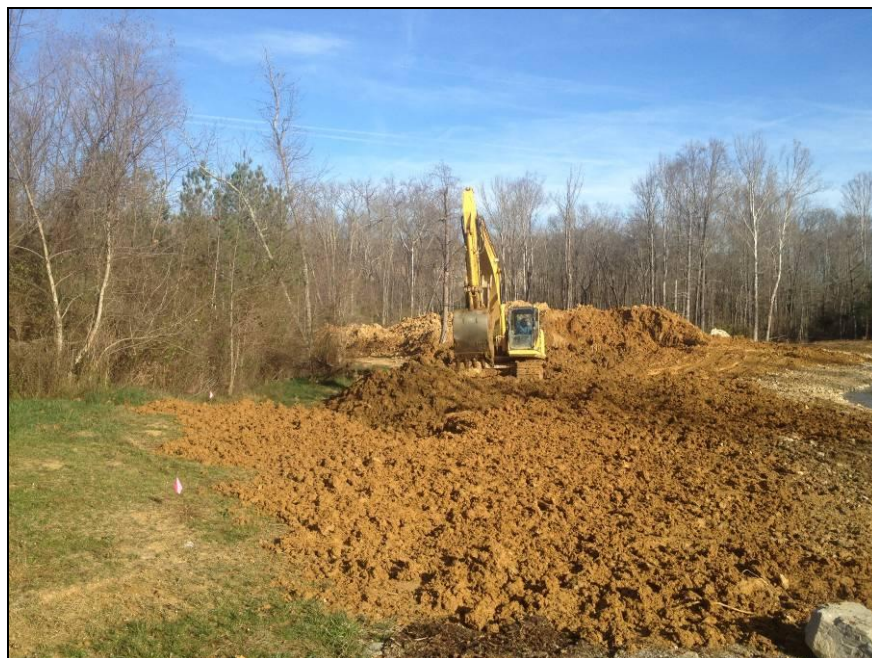
***Public Fishing Area: Filling temporary diversion channel with stockpiled soil once water was turned into new channel. (Picture taken on LDB at ~Sta. 102+00 looking downstream).***

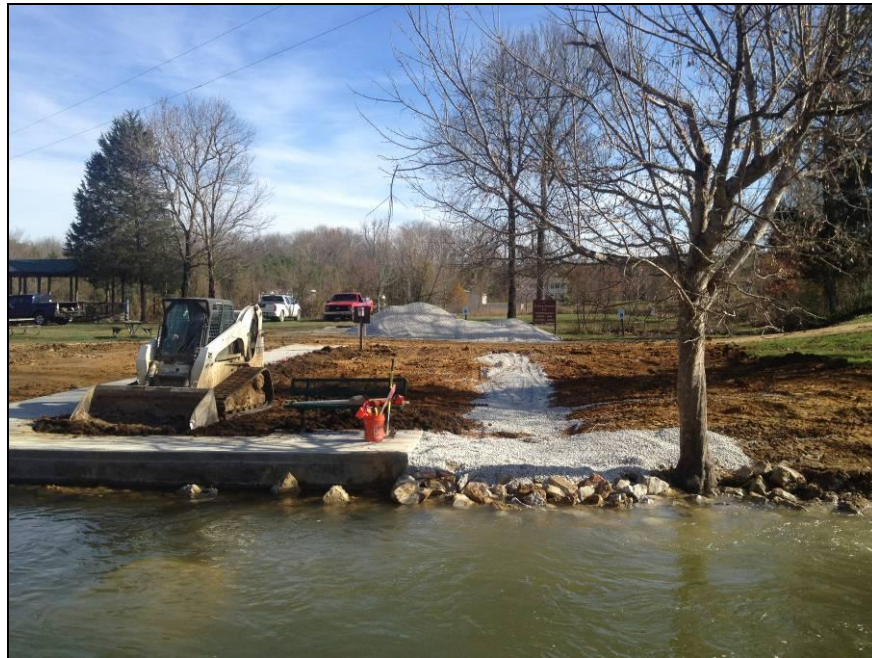
***Public Fishing Area: Installing new grass swale from parking lot (shown with rock French Drain to prevent standing water) and regrading around new sidewalk. (Picture taken from LDB looking across stream at approximate same location as above).***

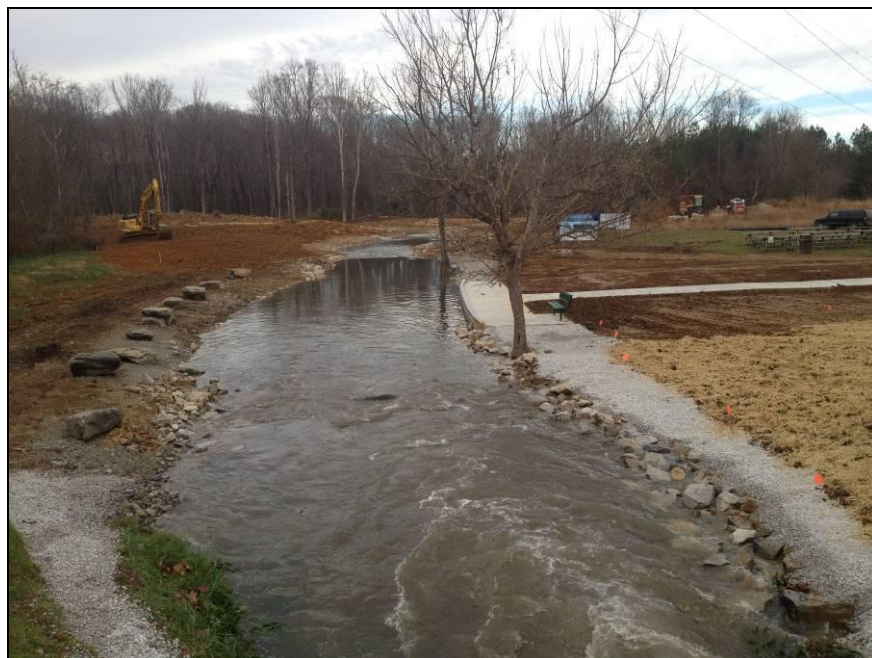
***Public Fishing Area: View of stream once water was turned into new channel and temporary diversion channel was filled. (Picture taken from culvert at exit from Hatchery looking downstream).***

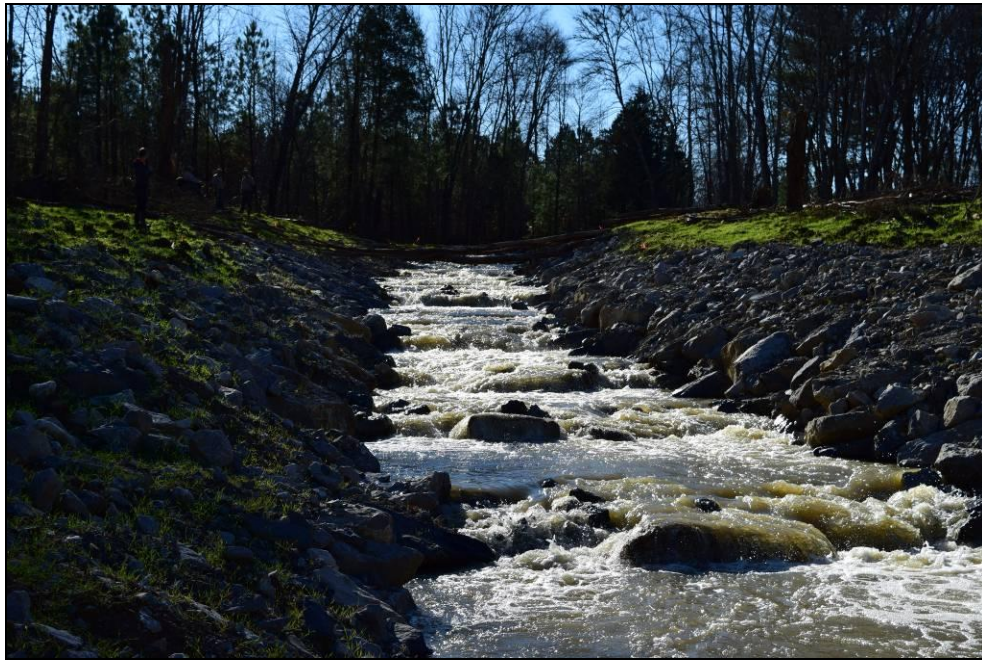
***Step Pool Reach: Two hours after the water was diverted into the new stream it was flowing at the step pool reach into the Cumberland River. (Picture taken looking upstream).***

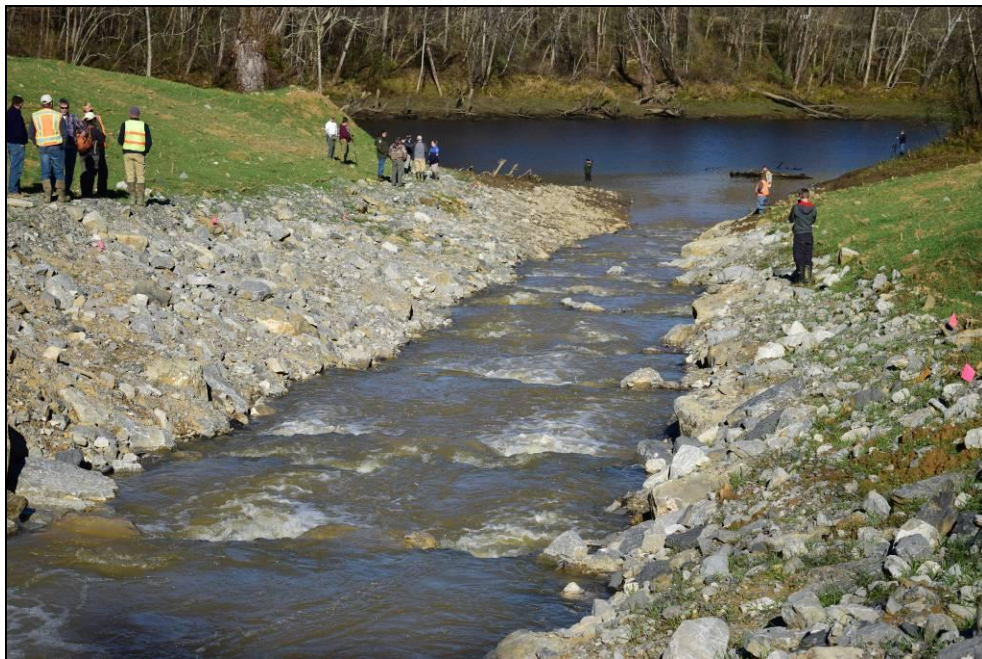
***Step Pool Reach: Two hours after the water was diverted into the new stream it was flowing at the step pool reach into the Cumberland River. (Picture taken looking downstream towards Cumberland River).***
